Inspecting Isolated Phase Bus For Deterioration

**J. E. Timperley
American Electric Power
Columbus, Ohio
jetimperley@AEP.com
j.e.timperley@ieee.org**

This paper discusses the basic design of isolated phase bus and how to identify several of the more common deterioration mechanisms through visual inspections, infrared and EMI measurements. Several examples are presented.

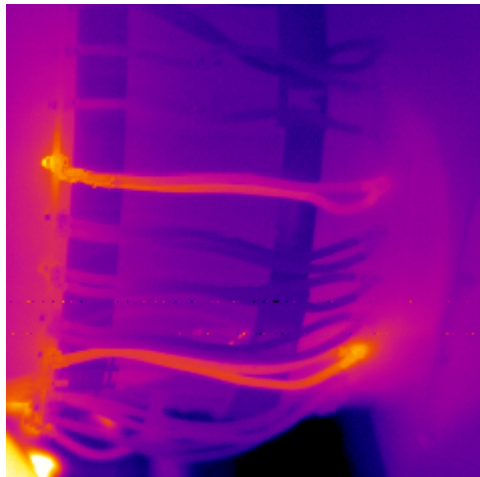
FIGURE 7: Infrared identifies deterioration of these bolted connections.

Routine infrared inspection along the full length of an isolated phase should be included as part of a good condition based maintenance program. The unequal heating of jumpers in Figure 7 indicates maintenance of several bolted joints is required. In this case the hot jumpers are the only ones carrying current. The cool jumpers have deteriorated high resistance connections and are not carrying current.

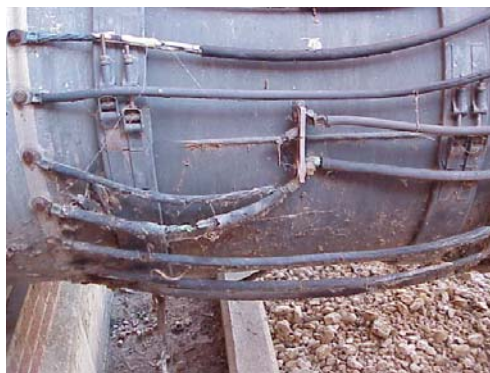
FIGURE 8: In some cases a visual inspection will located deteriorated external jumpers.

External strap type enclosure jumpers are a constant source of problems if not properly designed and maintained. The system in Figure 8 consisted of copper cables bolted to an aluminum enclosure with steel bolts and no contact surface plating. The conductors were sized with no capacity margin and the cable insulation was not resistant to operating temperatures or UV deterioration.

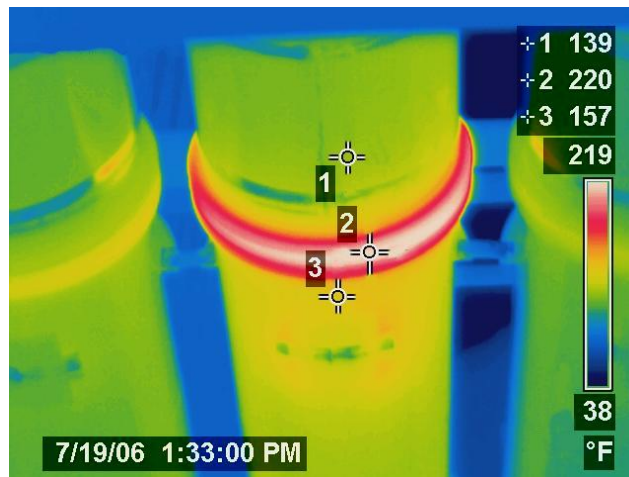
FIGURE 12: An infrared inspection of the welded bellows type enclosure expansion joints will detect any overheating resulting from age related cracks.

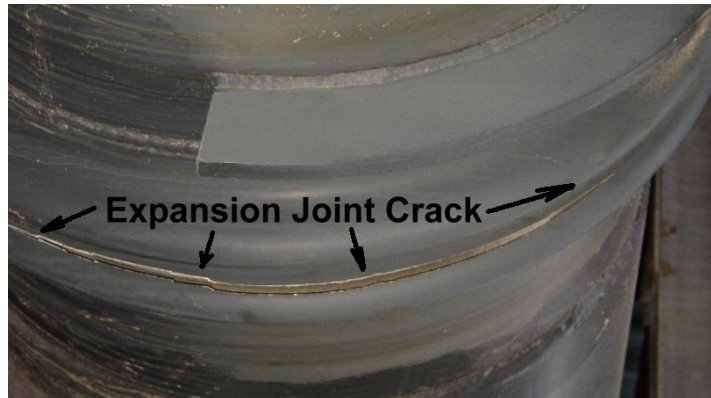
FIGURE 13: This crack is located on the opposite side of the overheating seen by an infrared inspection.

In general the welded type of expansion joints are more reliable than bolted designs. It has been noted that after 30 or more years of flexing these can also develop cracks.

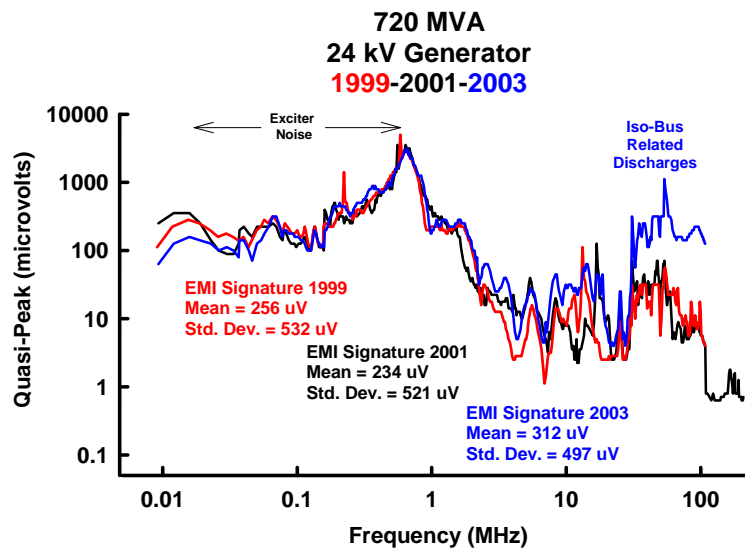
FIGURE 14: An EMI (electromagnetic interference) Diagnostic of the generator will detect deterioration of an isolated phase bus. Bus problems are seen at the higher frequencies.

Figure 14 shows the change in EMI signature of a large generator over several years. The 1999 curve (red) and the 2001 curve (black) are almost identical. The higher frequencies above 1 MHz increased in 2003 (blue). These frequencies and particularly those above 50 MHz describe the isolated phase bus. Measuring the radiated EMI along each bus enclosure will provide additional defect location information to focus an inspection on the correct phase and general location, Figure 15. An inspection was scheduled and the broken conductor shunts in Figure 16 were found. Rusty hardware, foreign metal objects, broken, loose and contaminated insulations have also been detected from on-line EMI Diagnostics.

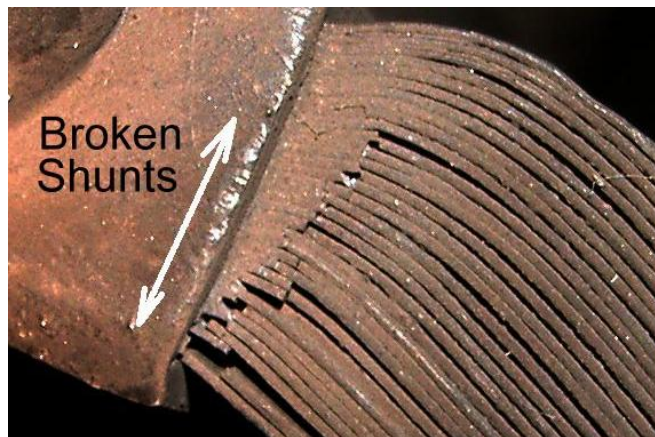
FIGURE 16: Broken shunts detected by the EMI Diagnostic. There was no external IR signature for this deterioration of the center conductor due to enclosure shielding.

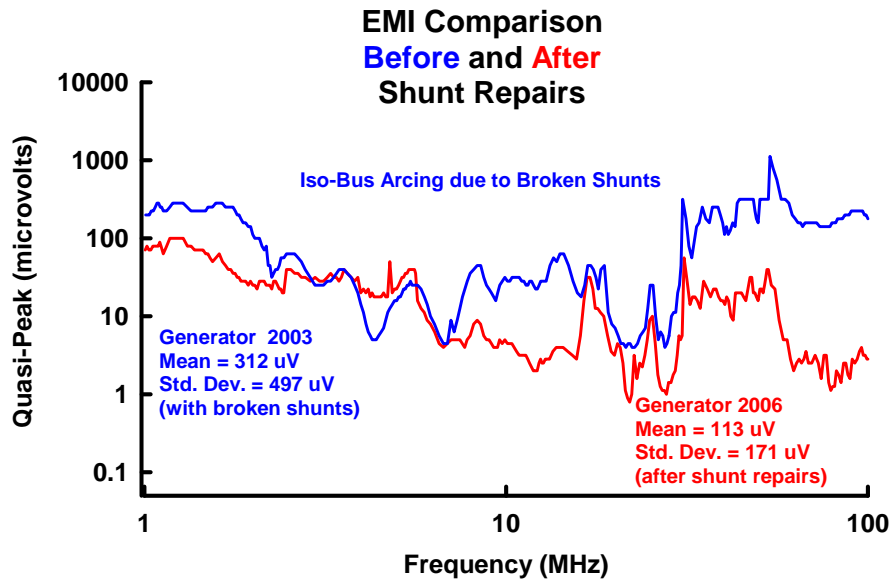
FIGURE 17: With broken conductor shunts repaired the high frequency EMI signature returned to earlier levels, confirming these repairs successfully corrected the problem.

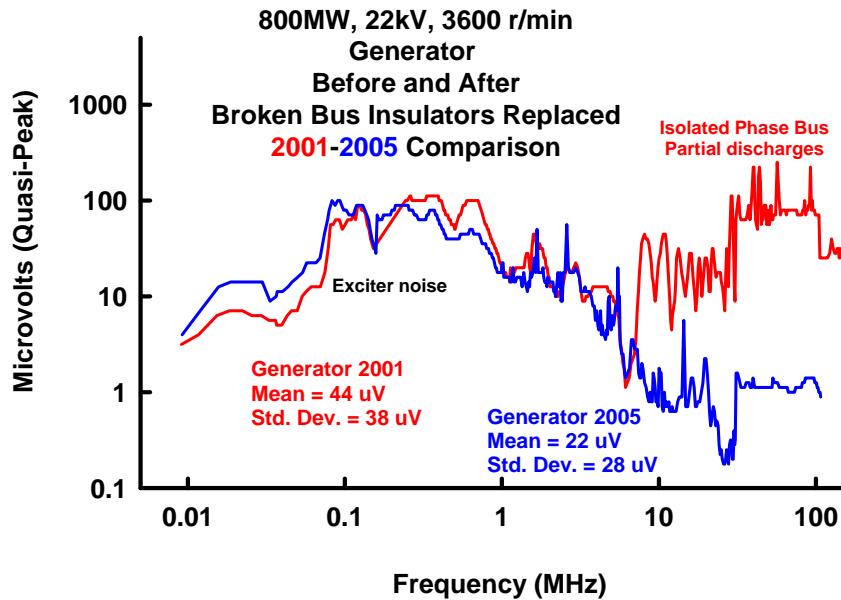
FIGURE 18: The 2001 EMI signature for this generator indicated severe bus deterioration.

An EMI Diagnostic of this generator system discovered high levels of bus related partial discharges. This bus is subject to high vibration levels due to a floor resonance condition. The 2003 inspection located six separated support insulators, Figure 19. After insulator replacement the EMI signature returned to “normal”. The floor was de-tuned from 120 Hz.

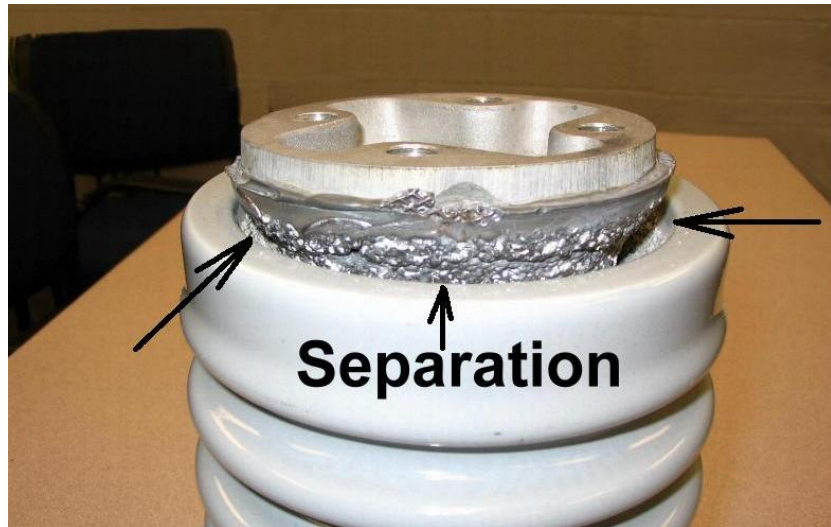
FIGURE 19: A bus inspection of the system in Figure 18 found six insulators with loose mounting inserts.

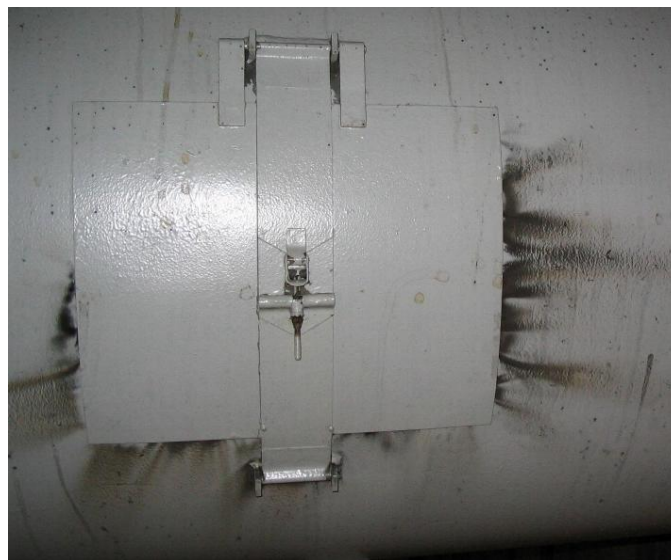
FIGURE 20: Forced air-cooled isolated phase buses often develop air leaks around the inspection hatches due to hardening of the original gasket material.

Deterioration of the rubber gaskets around bus inspection hatches can be expected. The original material was not intended to remain pliable for longer than 10-15 years. In some cases the seal was compromised within 5 years due to higher than expected operating temperatures. Materials available today such as silicone rubber sponge can be applied as a permanent replacement gasket. This 180° C temperature rating material has proven to remain an effective air seal after 20 years of operation. Similar deterioration of the enclosure air seal near the GSU Figure 21 is also common. Replacement with silicone based material is recommended.

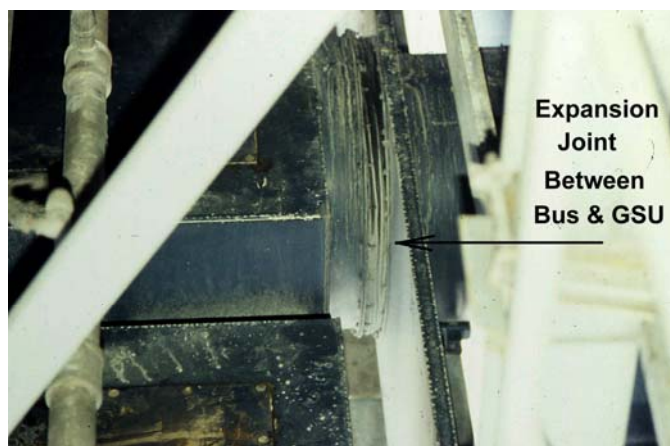
FIGURE 21: Deterioration of the air seal between bus and GSU can be expected.

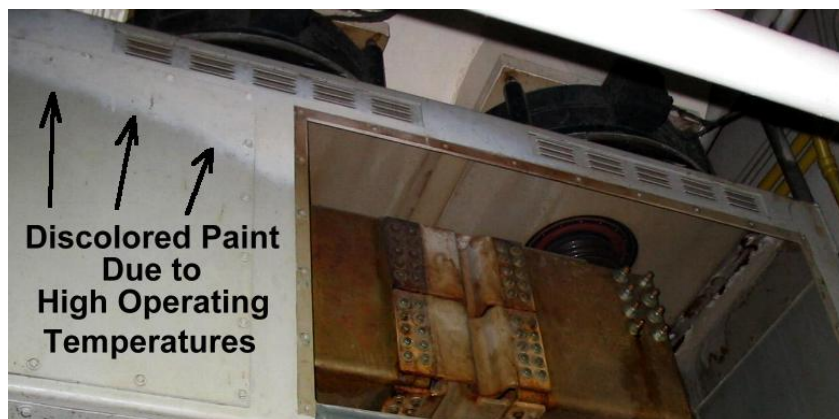
FIGURE 22: The neutral enclosure under a generator is a section of bus often over looked.

The neutral bus in Figure 22 carries 30,000 amps with out forced cooling. Enclosure circulating currents and operating temperatures were sufficient to deteriorate the surface paint. An infrared inspection would have clearly shown this problem. Since many systems are being upgraded with more efficient turbines the resulting higher operating temperatures may result in more than chalked paint. Additional ventilation holes were added to the enclosure in Figure 22 to improve convection cooling.
