Inspecting Isolated Phase Bus For Deterioration

**J. E. Timperley
American Electric Power
Columbus, Ohio
jetimperley@AEP.com
j.e.timperley@ieee.org**

This paper discusses the basic design of isolated phase bus and how to identify several of the more common deterioration mechanisms through visual inspections, infrared and EMI measurements. Several examples are presented.

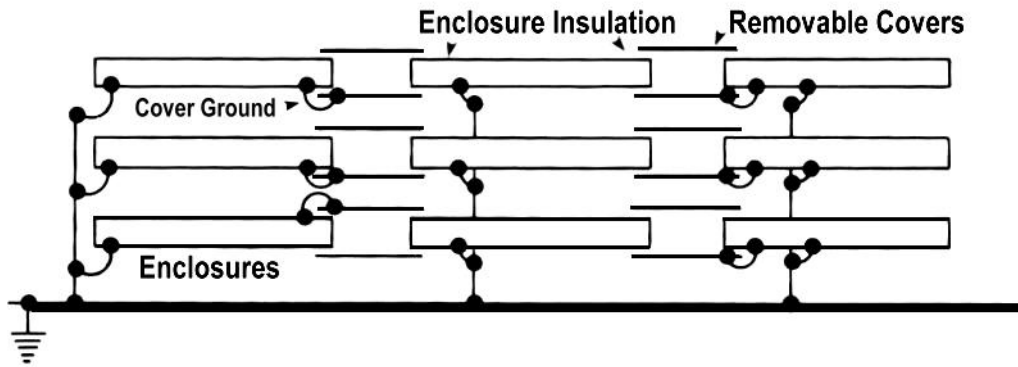
FIGURE 1: Isolated phase bus with non-continuous enclosures is a common design provided since the 1950's and remains available today.

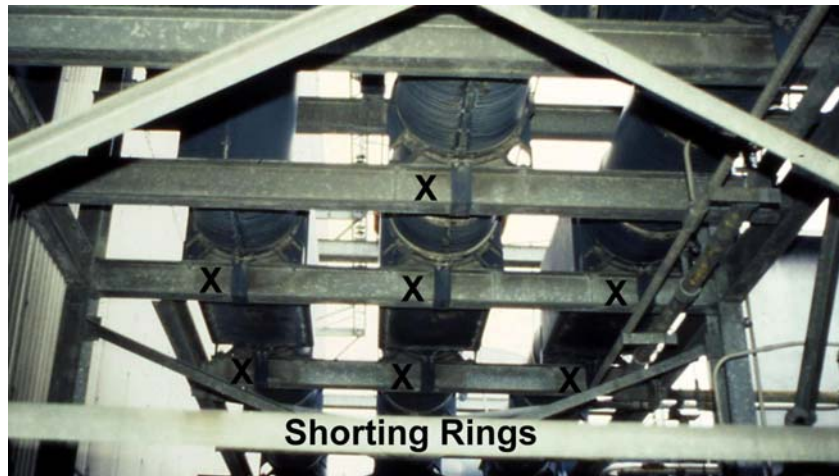
FIGURE 2: Copper shorting rings around the supporting steel under each enclosure is a positive indication the bus has non-continuous enclosures.

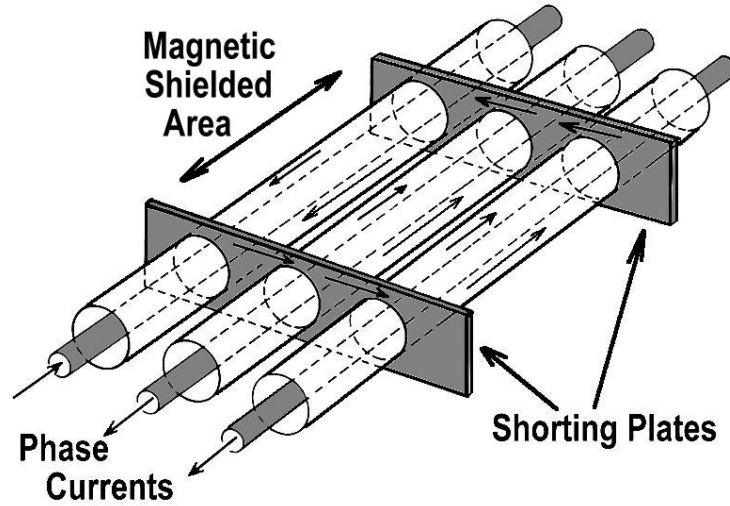
FIGURE 5: The continuous enclosure design has almost full phase current flowing in each of the three enclosures.

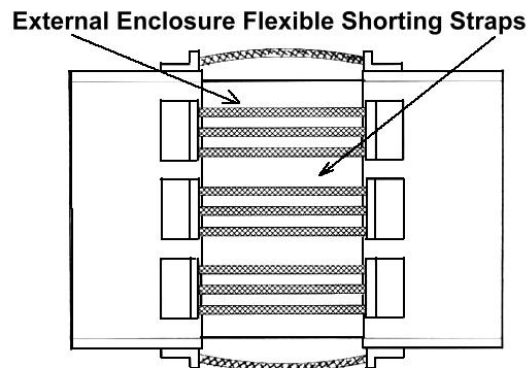
FIGURE 6: Expansion joint straps are welded to the enclosure in this design.

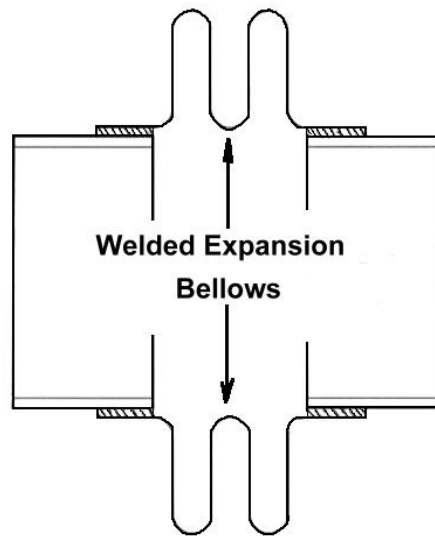
FIGURE 11: Another method to maintain enclosure continuity and provide for thermal expansion is the addition of welded flexible aluminum bellows.

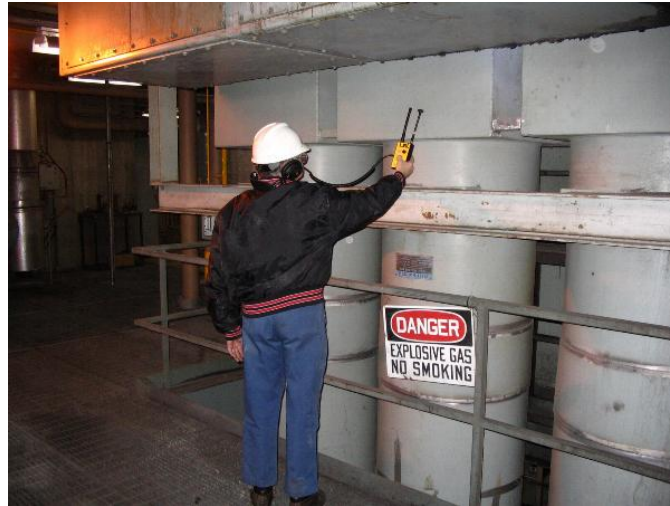
FIGURE 15: A hand held EMI detector is used to establish the location of a defect.
